## Technical Bulletin

### Taper Roller Bearings

**Memo: Running band on raceway**

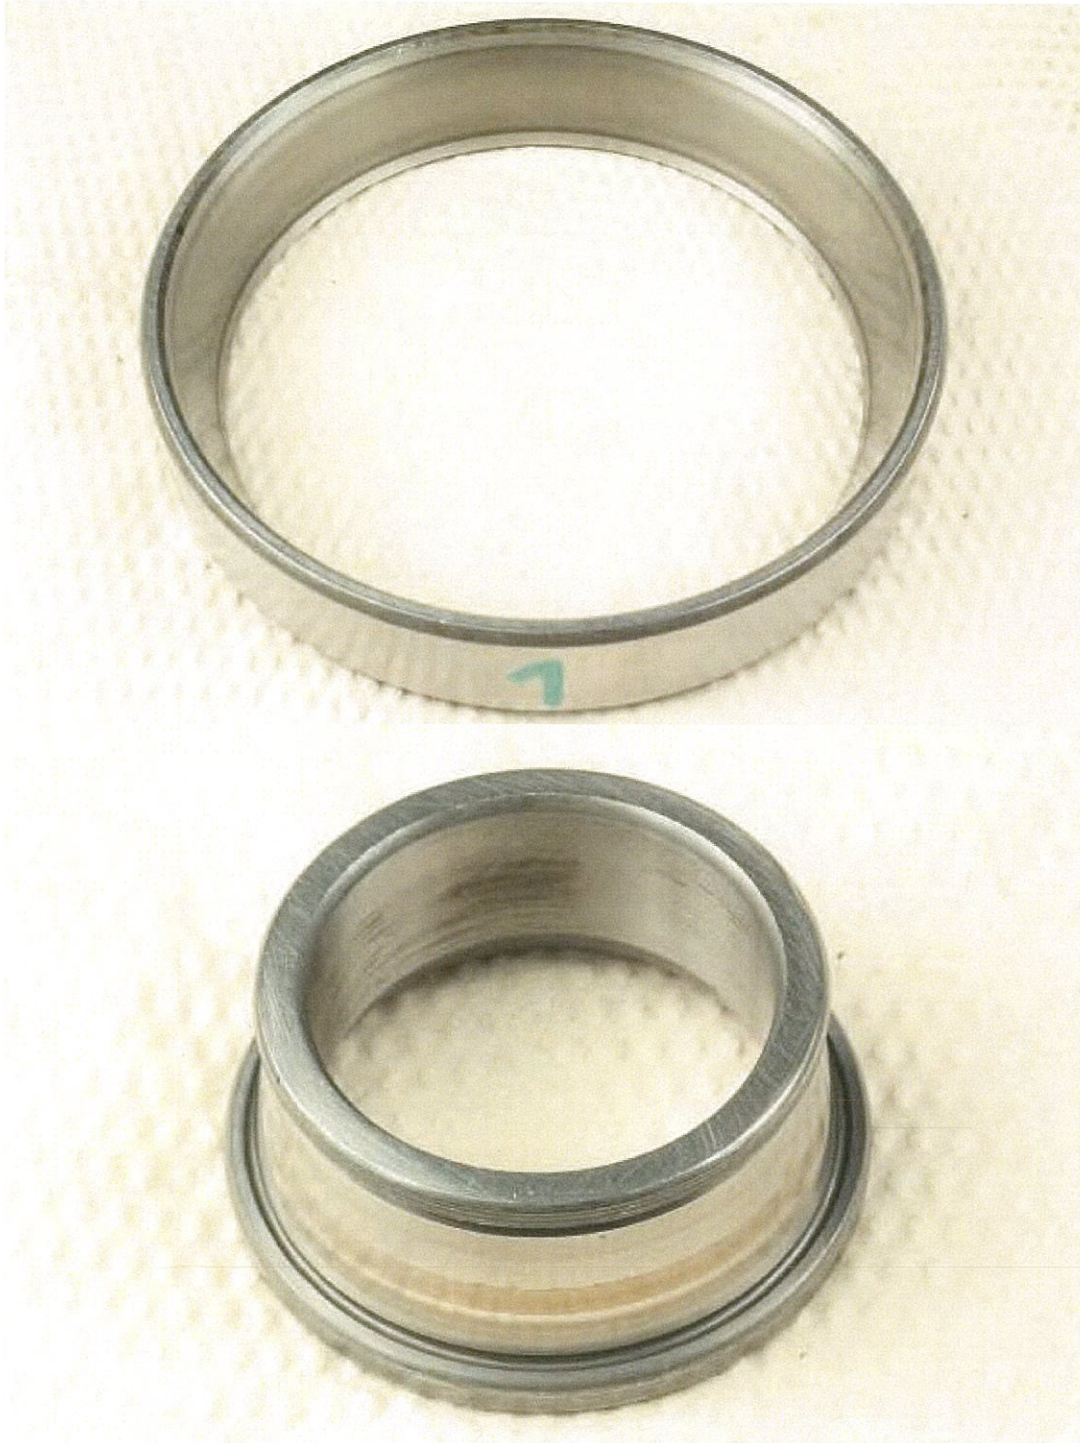
The investigation found no abnormalities. The bearings were found to be in good operating condition and well within NSK's specifications. Running bands can be common when the bearing is subject to an external load. The discoloration will have no effect on the life of the bearing therefore no need to change out the bearings.

Please refer to the following page for the running band examples.

Bearing replacement should only occur if pitting of the cup or rollers of the cone are evident.
